LOYALHANNA CREEK WATERSHED

Priority Assessment & Restoration **Plan**

A project of the Loyalhanna Watershed Association, with technical assistance provided by the Western Pennsylvania Conservancy.

June, 2021

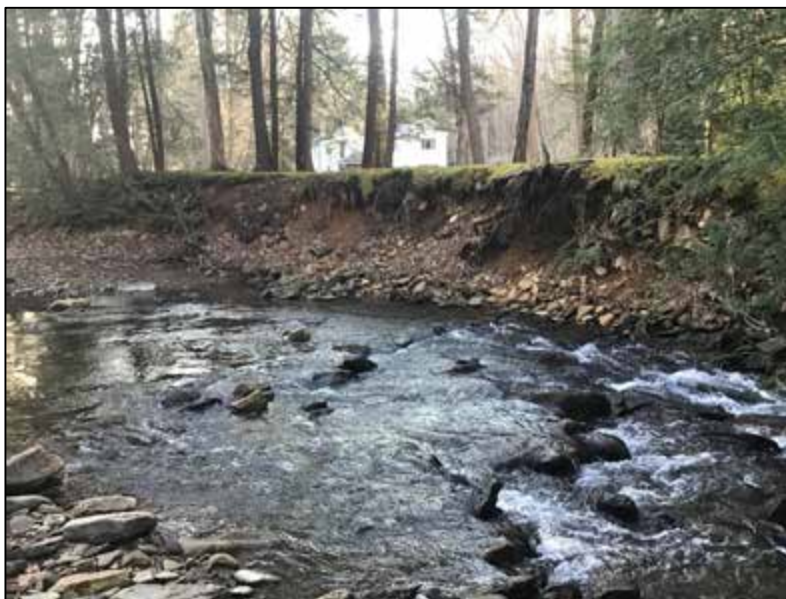
Eroded streambank along Laughlintown Run

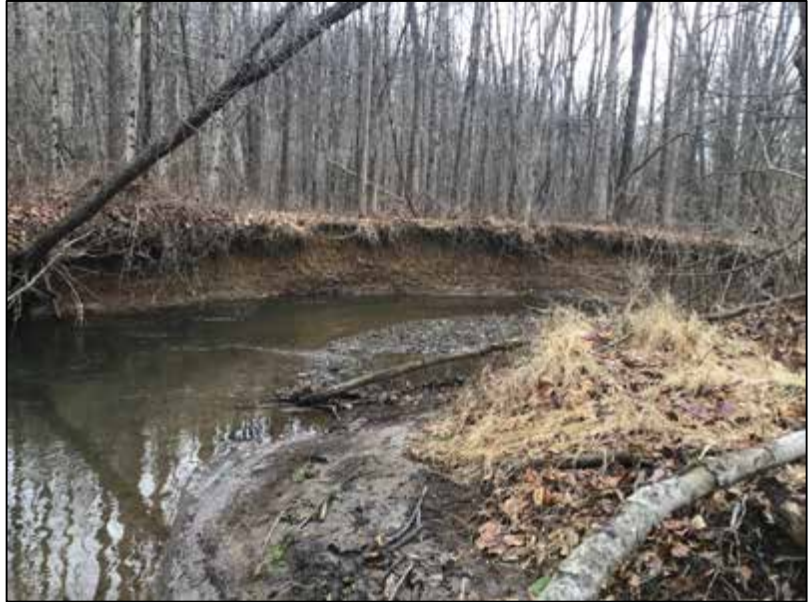
Eroded, silty banks are prevalent along Hannas Run

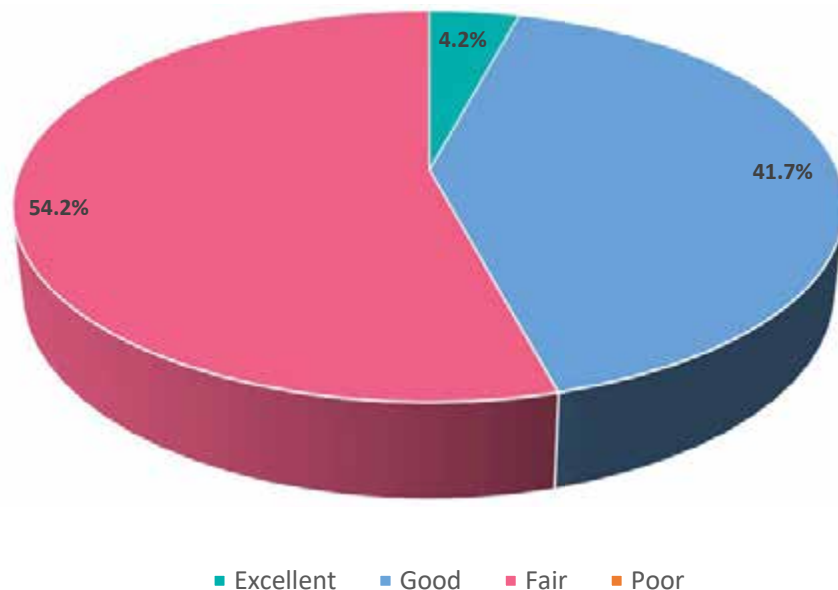
Figure 9: 2020 Mill Creek Assessment Results

Overall, the portions of the Mill Creek subwatershed assessed are in fair to good condition, due to the positive impacts from past streambank restoration and agricultural BMP’s being installed within this area. Many of the residential and commercially developed areas along the mainstem in particular have significant riparian zone encroachment (roads and residential houses), which reduce the effectiveness of a functional riparian buffers.

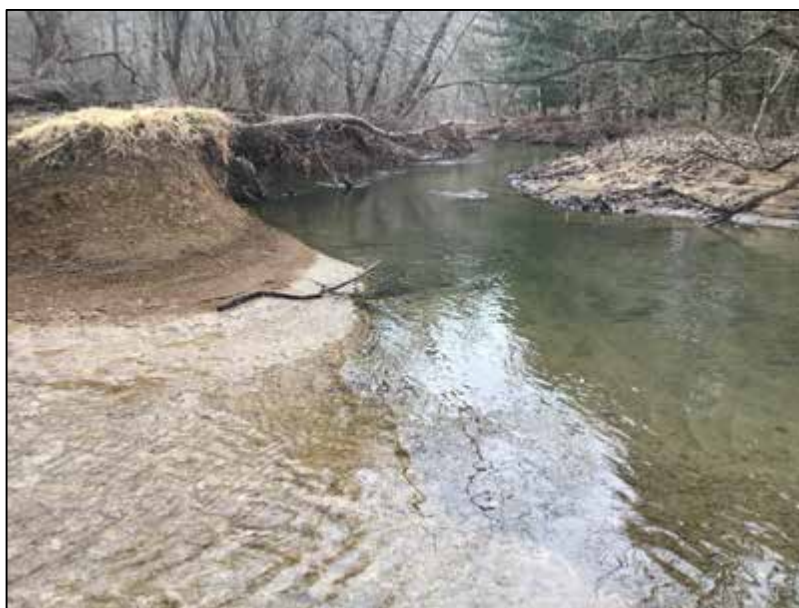
Extensive erosion exists along sections of Fourmile Run

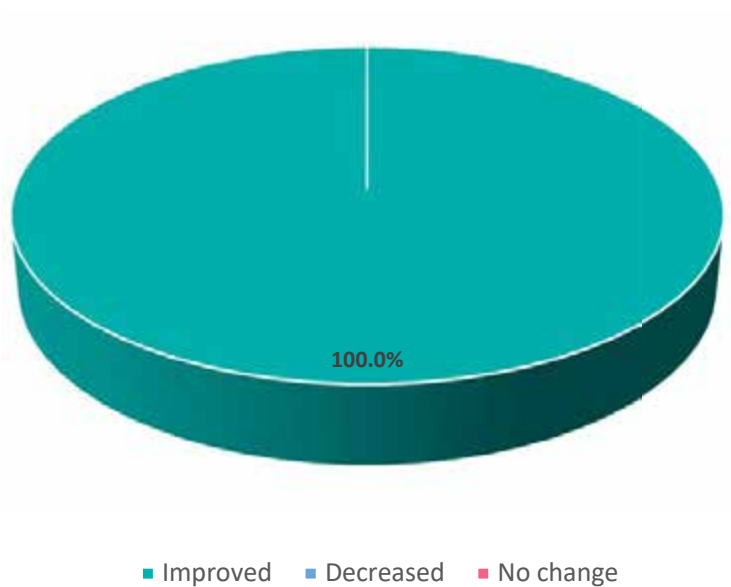
Figure 19: 2020 Saxman Run Assessment Results

Overall, the portions of the Saxman Run drainage assessed are in fair condition. The West Derry, Upper Saxman and Lower Saxman Run AMD Discharges were located through the area that was re-assessed, and future treatment of these should be further investigated. Precipitated iron oxide is apparent throughout the lower reaches of Saxman Run. Developed areas have significant riparian zone encroachment (roads and residential houses) which reduce the effectiveness of a functional riparian buffers.

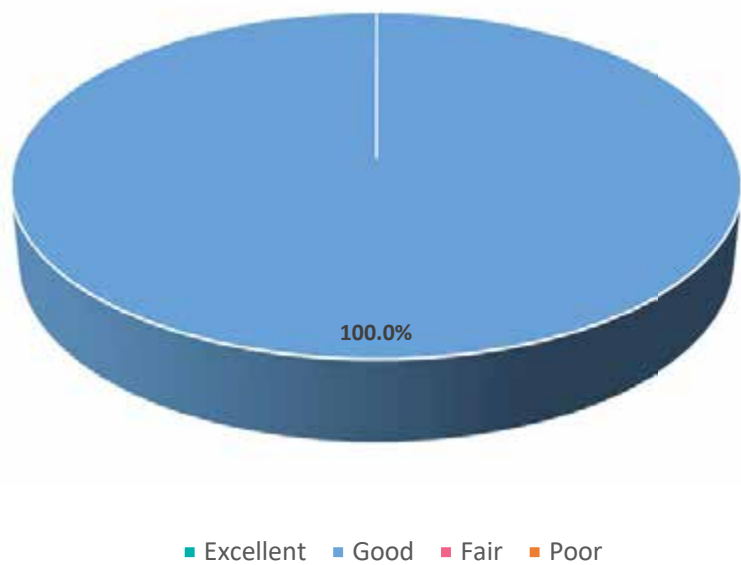
Figure 21: 2020 Union Run Assessment Results

Overall, the portions of the Union Run assessed are in good condition. AMD discharges seem to be the primary source of water quality impairment within this subwatershed. Many of the developed areas have significant riparian zone encroachment (roads, agriculture, and residential houses) which reduce the effectiveness of a functional riparian buffers.
